# CONTROLLING VARNISH

NEW AND UPGRADED SYSTEMS AIM TO REMOVE AND PREVENT VARNISH

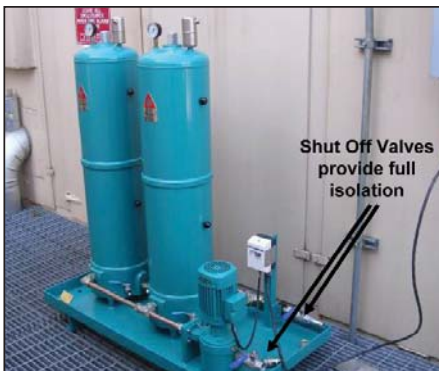
**Figure 1: C.C. Jensen's varnish removal skid has four replaceable cellulose filters, each capable of removing 8 lbs of varnish**

C.C. Jensen's (Svendborg, Denmark) static filters (Figure 1) are made of cellulose fiber and remove the varnish using the principle of adsorption in which the particles bind to the surface of the media as opposed to being absorbed in the filter media. Therefore, the capacity to adsorb varnish particles improves with surface area. One gm of cellulose has a surface area of 400 m<sup>2</sup>, and one filter insert has 3,628 gms of cellulose — equivalent to the surface area of 302 football fields. Filter changes are recommended once every six months or a year, depending on the severity of service.

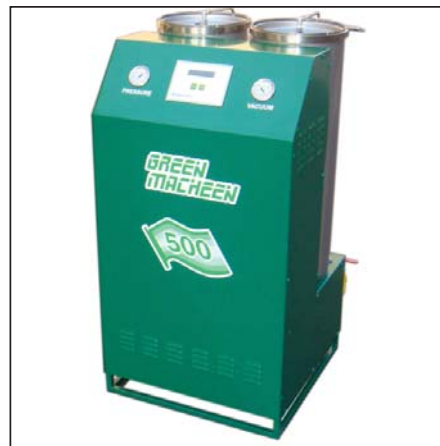
**Figure 2: Oilkleen's Green Macheen 500 creates 18 static energy fields and allows a flow rate of 500 gallons per hour**

The Oilkleen Green Macheen (Figure 2) by Oilkleen International, Inc. (Scottsdale, AZ) has a series of electrostatic oil filters that create 18 energy fields. The contaminated oil is forced through these fields at a specific flow rate. The 15,000 V of energy inside each field pulls the sub-micron contamination particles out of the oil. The fluid contamination particles bond to the millions of sharp edges in the collection media inside the Oilkleen filter cartridge. Field trials on a GE Frame 7 show a reduction in the QSA varnish potential rating — a standard test by Analysts, Inc. — from 85 to 7 within seven days of installing the Green Macheen.

A single unit removes both water contamination and varnish. The computer in the unit detects and removes water down to 25 ppm.

classifications: 300, Water-X, 500. Oil chiller is optional in 300 and 500, while Water-X has water-removal features. The 300 machine has a flow rate of 300 gallons/hour and has a 12-gallon tank capacity. The Water-X has a flow rate of 300 gallons-hour and a tank capacity of 24 gallons. The 500 has a flow rate of 500 gallons per hour and a tank capacity of 24 gallons.

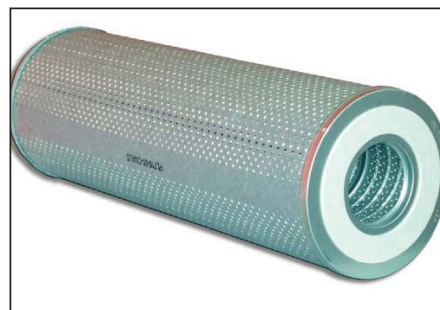
**Figure 3: Hilliard has introduced anti-static filter elements that reduce static discharge and promote lube oil conductivity**

Hilliard has introduced new filter elements that reduce the occurrence of static discharges. These impregnated filter media (Figure 3) improve the lube oil's conductivity, the company claims. One commercial size 718 element of this filter medium is capable of treating up to 3,000 gallons of lube oil.

According to Hilliard, field trials demonstrate that the company's anti-static filter elements reduce the lube oil's moisture content and Total Dissolved Gases content. Gases dissolved in the lube oil are a key cause of micro-dieseling that creates sub-micron particles leading to varnish formation. ■
